# Geo-Strata

## Geo-Grouting

# Pre-Excavation Grouting of Contact Zone and Rock Formation

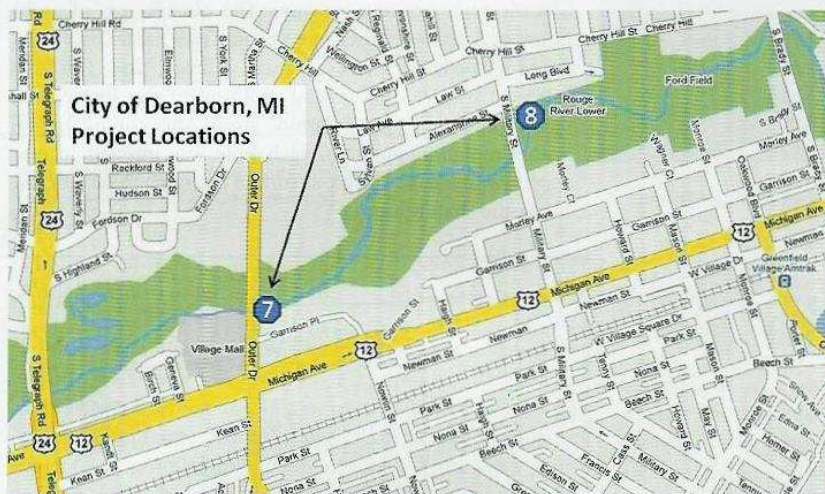
Figure 1. City of Dearborn, plan of CSO sites (courtesy of Layne GeoConstruction).

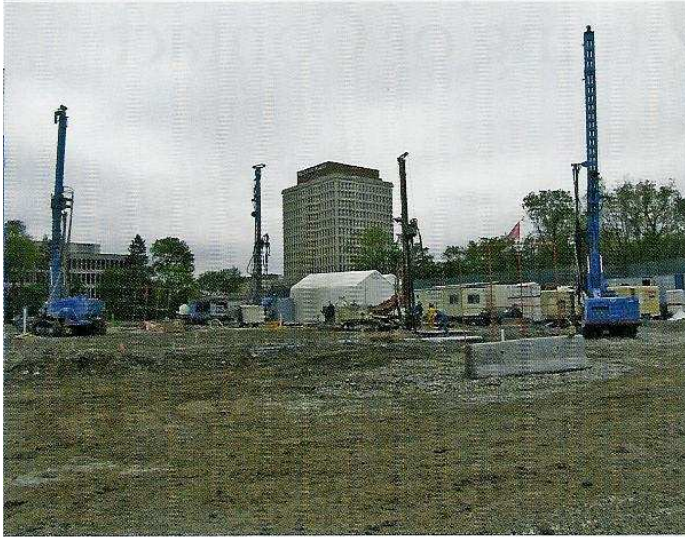
Figure 2. Production oriented drill rigs during drilling of grout holes (courtesy of Layne GeoConstruction).

The Contact Zone grouting program involved the installation of a double row grout curtain around the perimeter of the future shafts. Each grout hole was cased and drilled 3 ft into competent rock. The overburden was drilled using a rotary duplex with air and water flush through 75-85 ft of glacial silts and clays, 10-20 ft of sand, silt, and gravel (hardpan), and 10-20 ft of clay, silt, sand, and gravel to the rock interface. An overburden casing outfitted as a sleeve pipe (OCSP) was installed into the bottom of the cased hole and extended by riser pipe to the ground surface, through which grouting could later take place. Barrier bags inflated with cement-based grout were installed within the hardpan zone to eliminate artesian flow conditions during grouting operations. All drilling and installation of OCSP was conducted prior to the acrylamide grouting program.
